White Rock Quarry MINE OPERATIONS PLAN REVIEW

Prepared for:
Hanson Construction Materials Pty Ltd

Date:
16 April 2024

File Ref:
1901.600.001v2

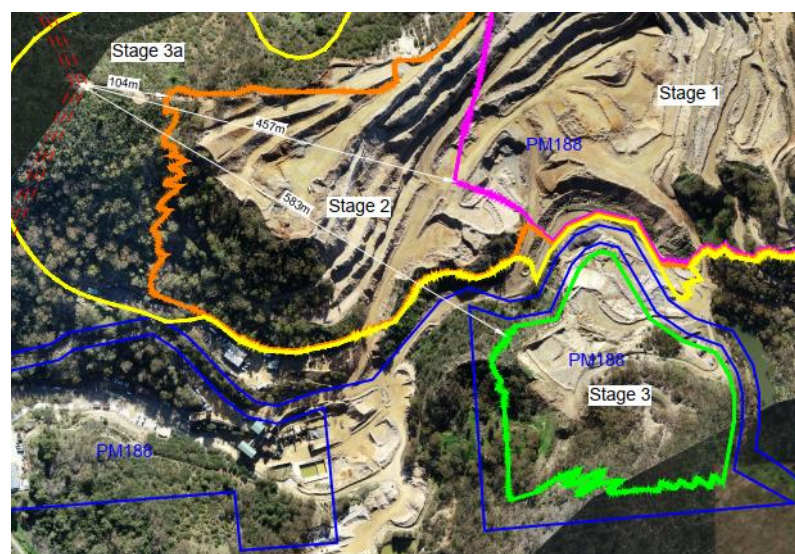
Diagram 1 – Separation Distances to Power Infrastructure

For the Site to transition into the final Stage (Stage 3A), the 275 kV ElectraNet transmission line that intercepts the site will require relocation. A decision point defined as 50 percent depletion of the Stage 2 estimated resource has been nominated to determine whether Stage 3A will proceed. Should it be determined that Stage 3A will proceed, a MOP review will be required. If the review determines that Stage 3A will not proceed a revised PMLUP and supporting rehabilitation strategy will be developed.

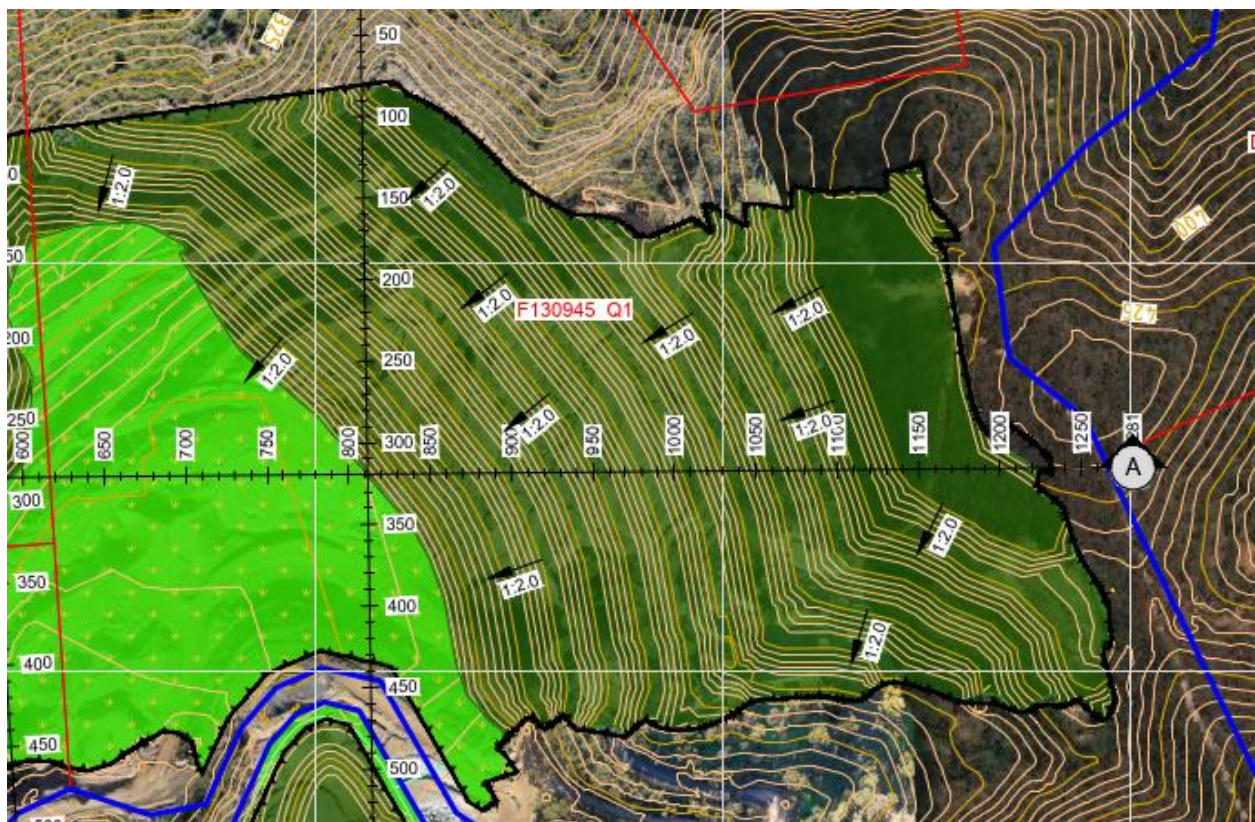
Diagram 2 – Rehabilitated Batter Profile

In order to support the desired rehabilitation for the Site, the rehabilitation batter profiles of the QDRPs for the Site support a one (1) Vertical (V) to two (2) Horizontal (H) (1V:2H) profile as can be noted within **Diagram 2 – Rehabilitated Batter Profile**.

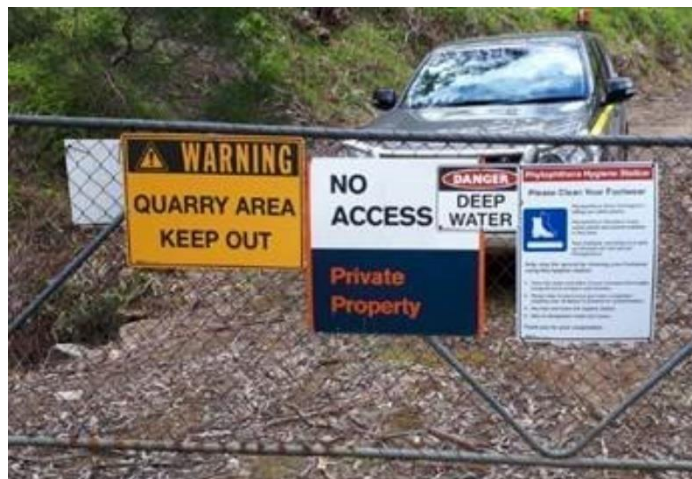
Photo 1 – No Access Signage

There are four (4) tracks that enter the Site via the adjacent conservation parks. Each of these tracks are secured with a locked gate and signage, an example of which is shown in **Photo 1 – No Access Signage**. In addition, security patrols are undertaken to ensure that trespassers are not present within the Site.
