PROJECT: **White Rock Quarry**

TITLE: **Quarry Development and Rehabilitation Plan - Stage 2**

DRAWING NUMBER: **1901.DRG.106**

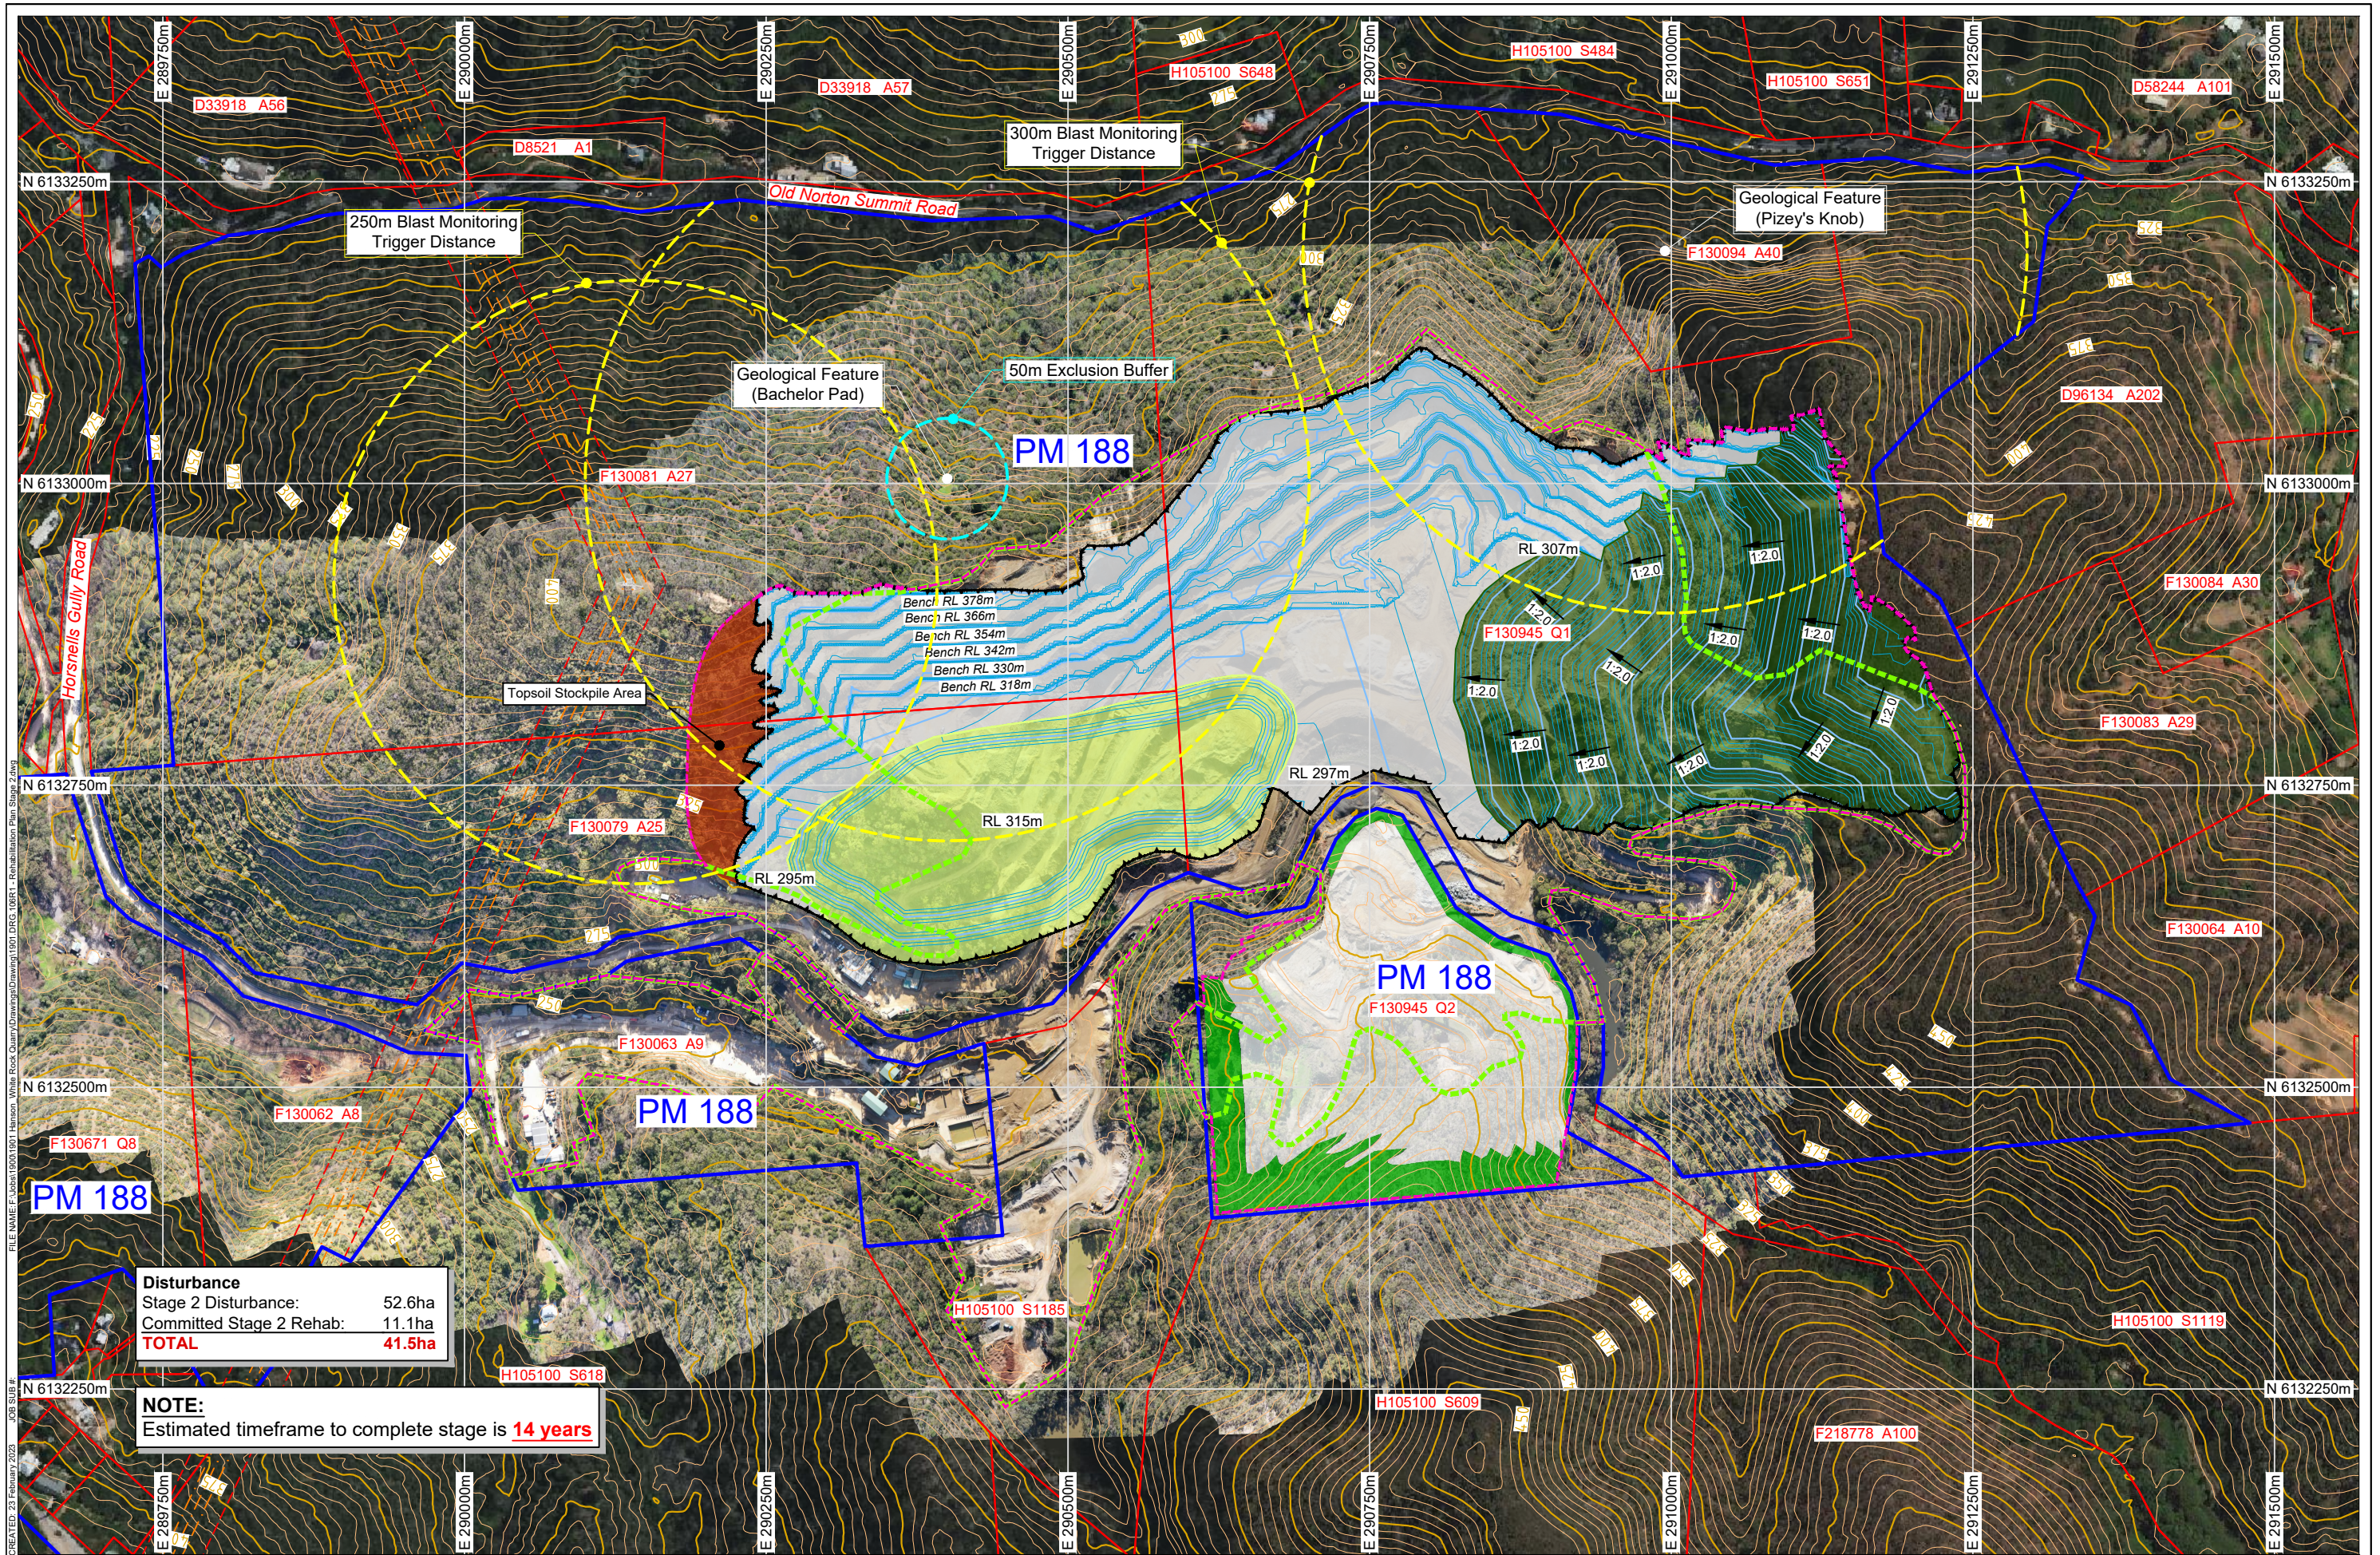
Disturbance	
Stage 2 Disturbance:	52.6ha
Committed Stage 2 Rehab:	11.1ha
TOTAL	41.5ha

NOTE:
Estimated timeframe to complete stage is **14 years**
